# New York State Department of Transportation

## PIA Safety Flag NB23CTW002

**BIN: 1065318**

Feature Carried: 278I278IX2M23027

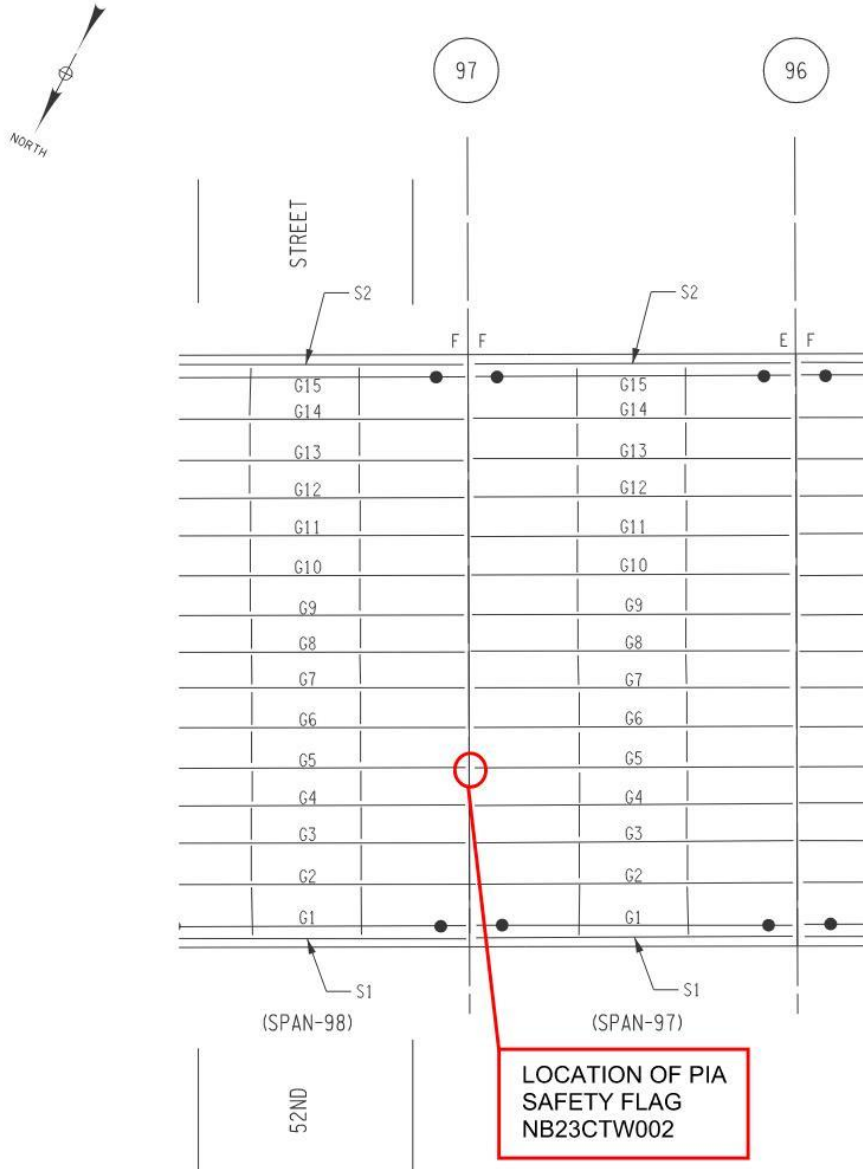
**Flag Photographs**Photo Number: **1**Photo Filename: **Location Plan - Span 97.jpg**

**Attachment Description: Flag Location Plan**

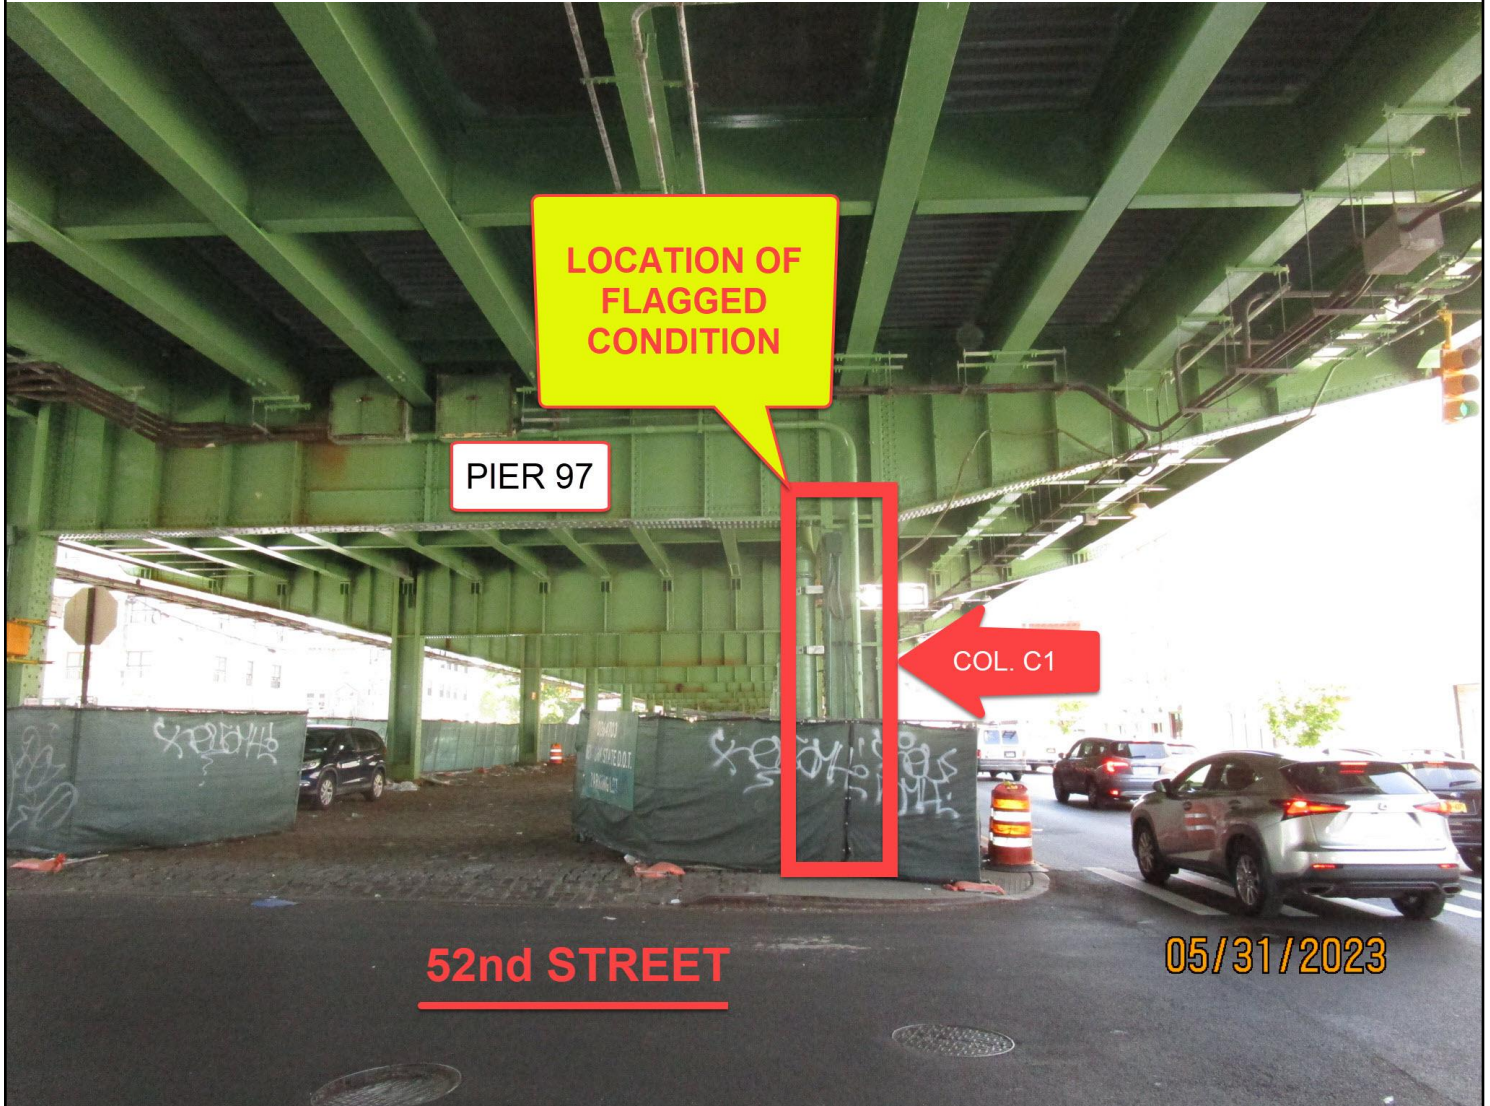
Photo Number: 2

Location: Span 97, Pier 97, Column C1 at base.

**Attachment Description: General view of Flagged Location at Pier 97. Looking Begin.**

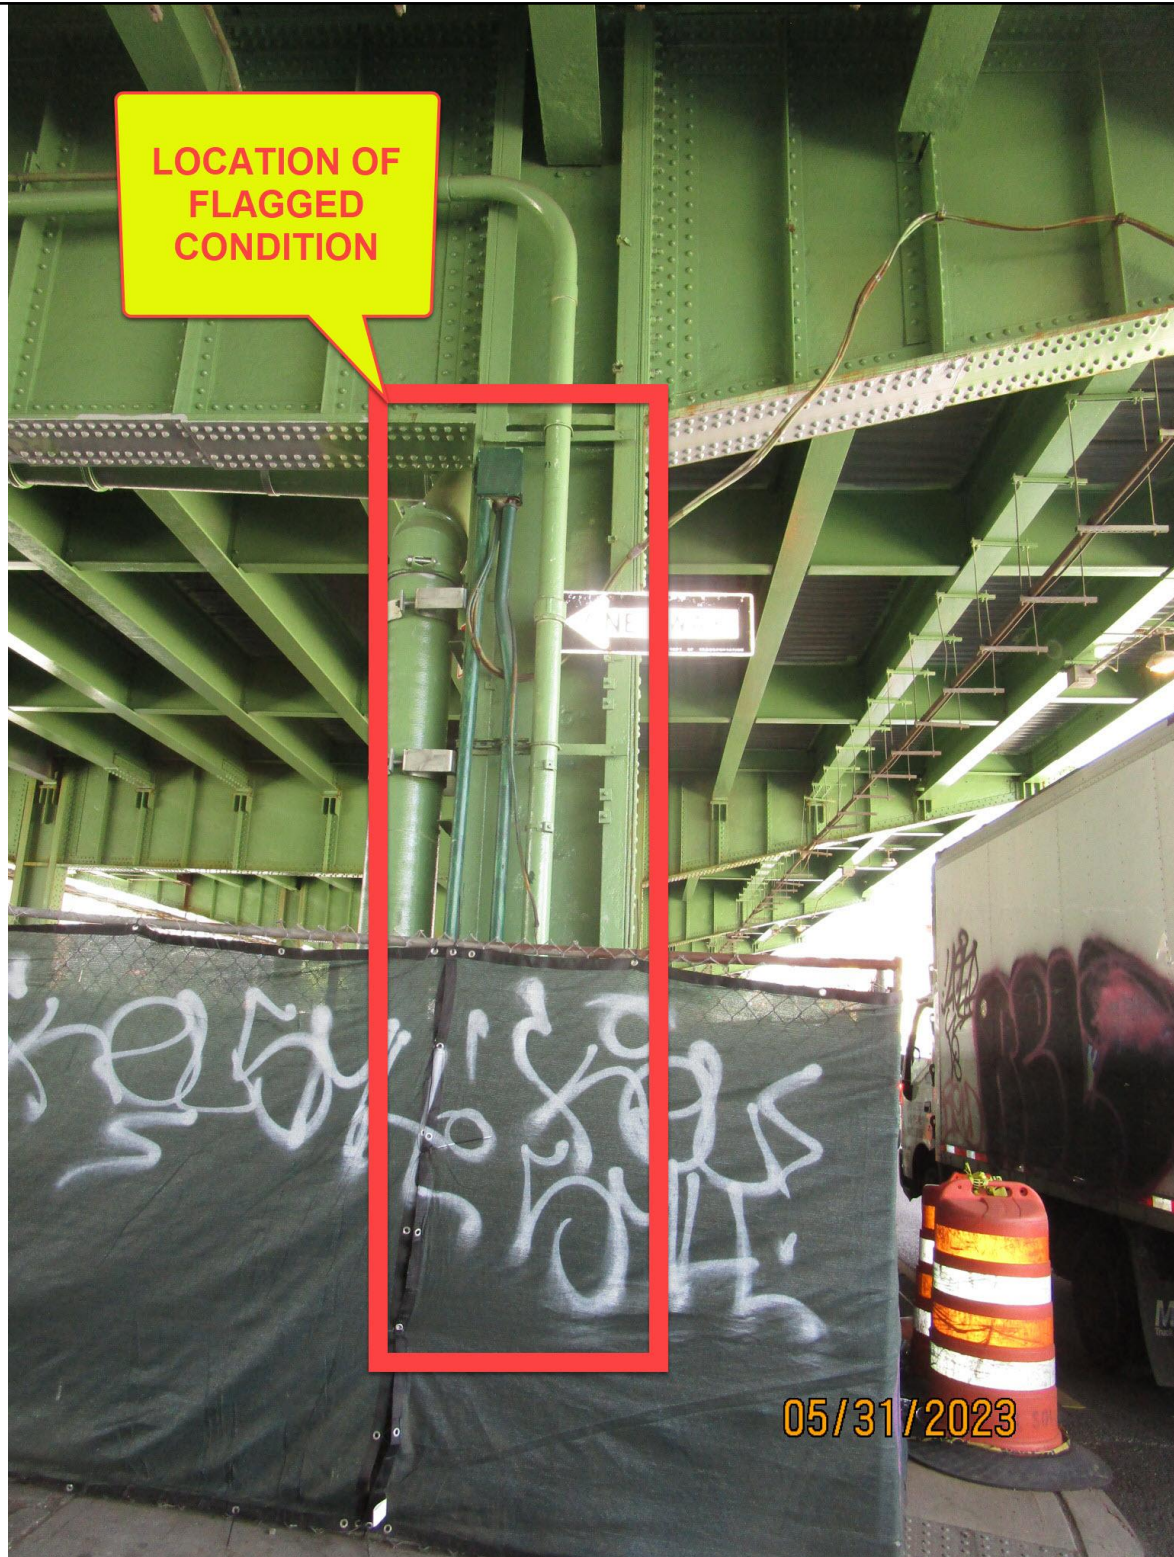
Photo Number: 3

An electrical cable at the end face of the column base exhibits voltage as tested with a "non-contact voltage detector". The cable is hanging from a junction box attached to the top of the column, and is cut at the lower end with exposed live wires.

**Attachment Description:** Location of Flagged condition at Pier 97, Column C1. Looking Begin.

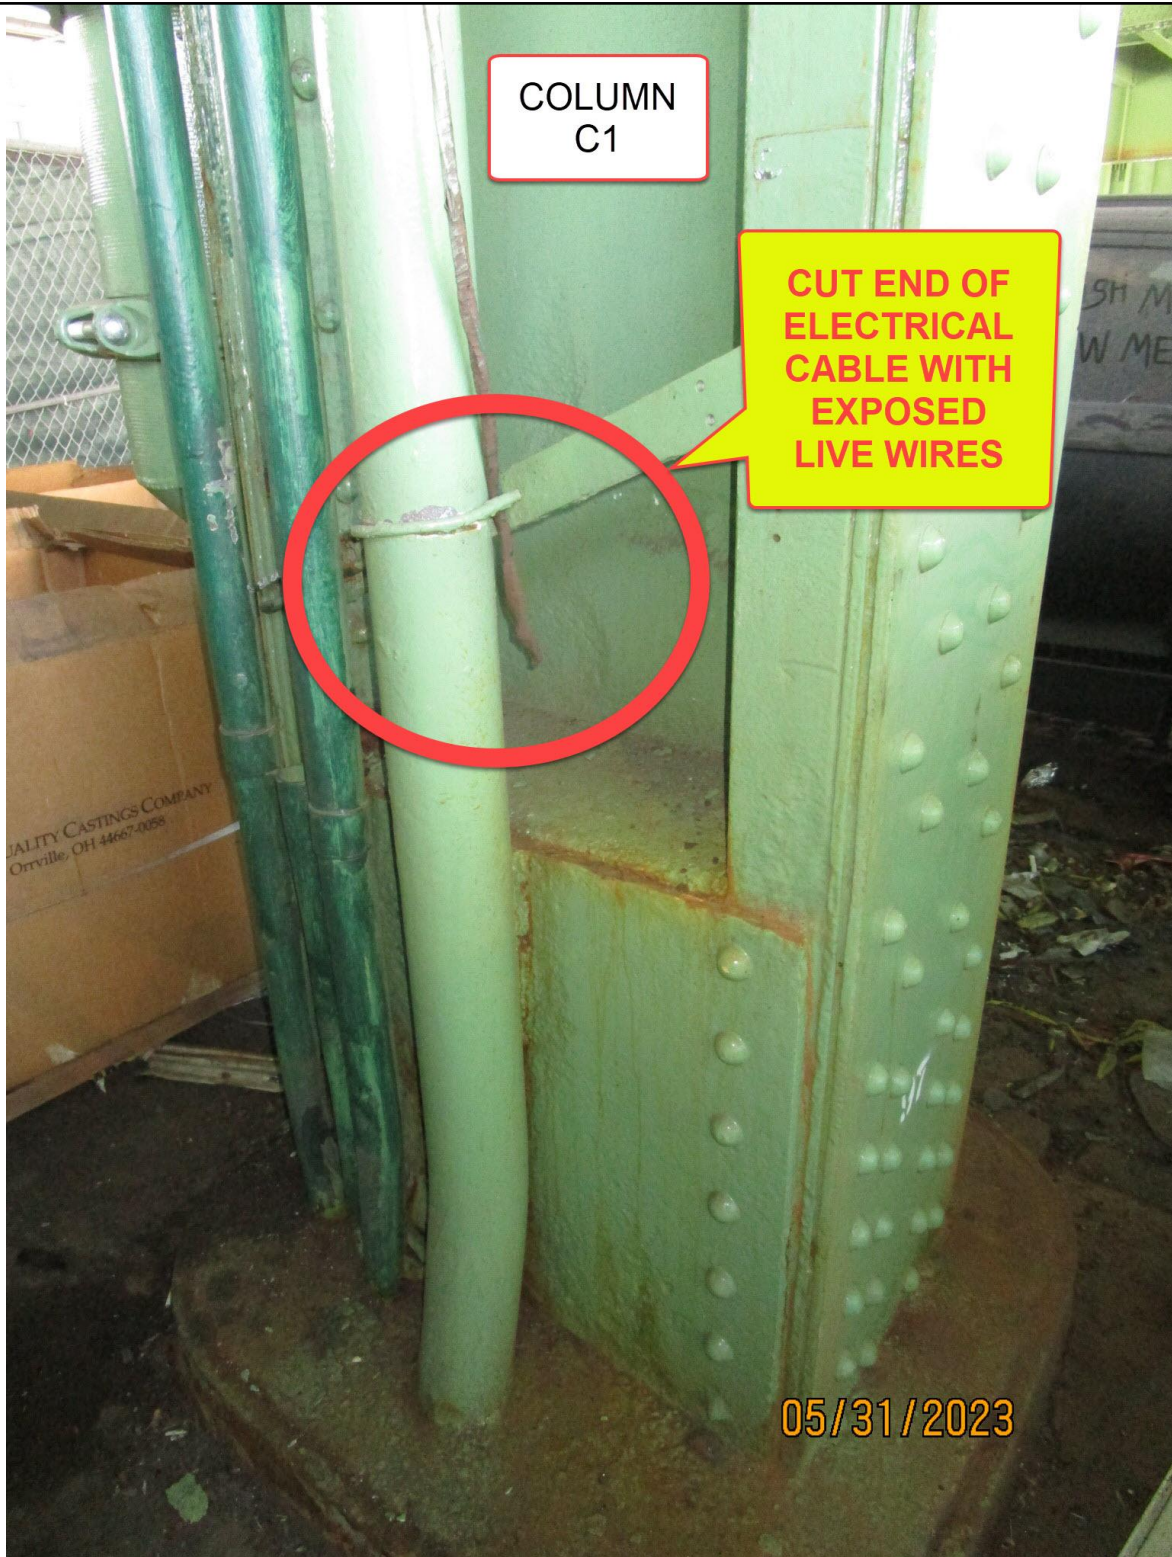
Photo Number: 4

**Attachment Description:** The end of the electrical cable is cut with exposed live wires. Looking Begin Right.

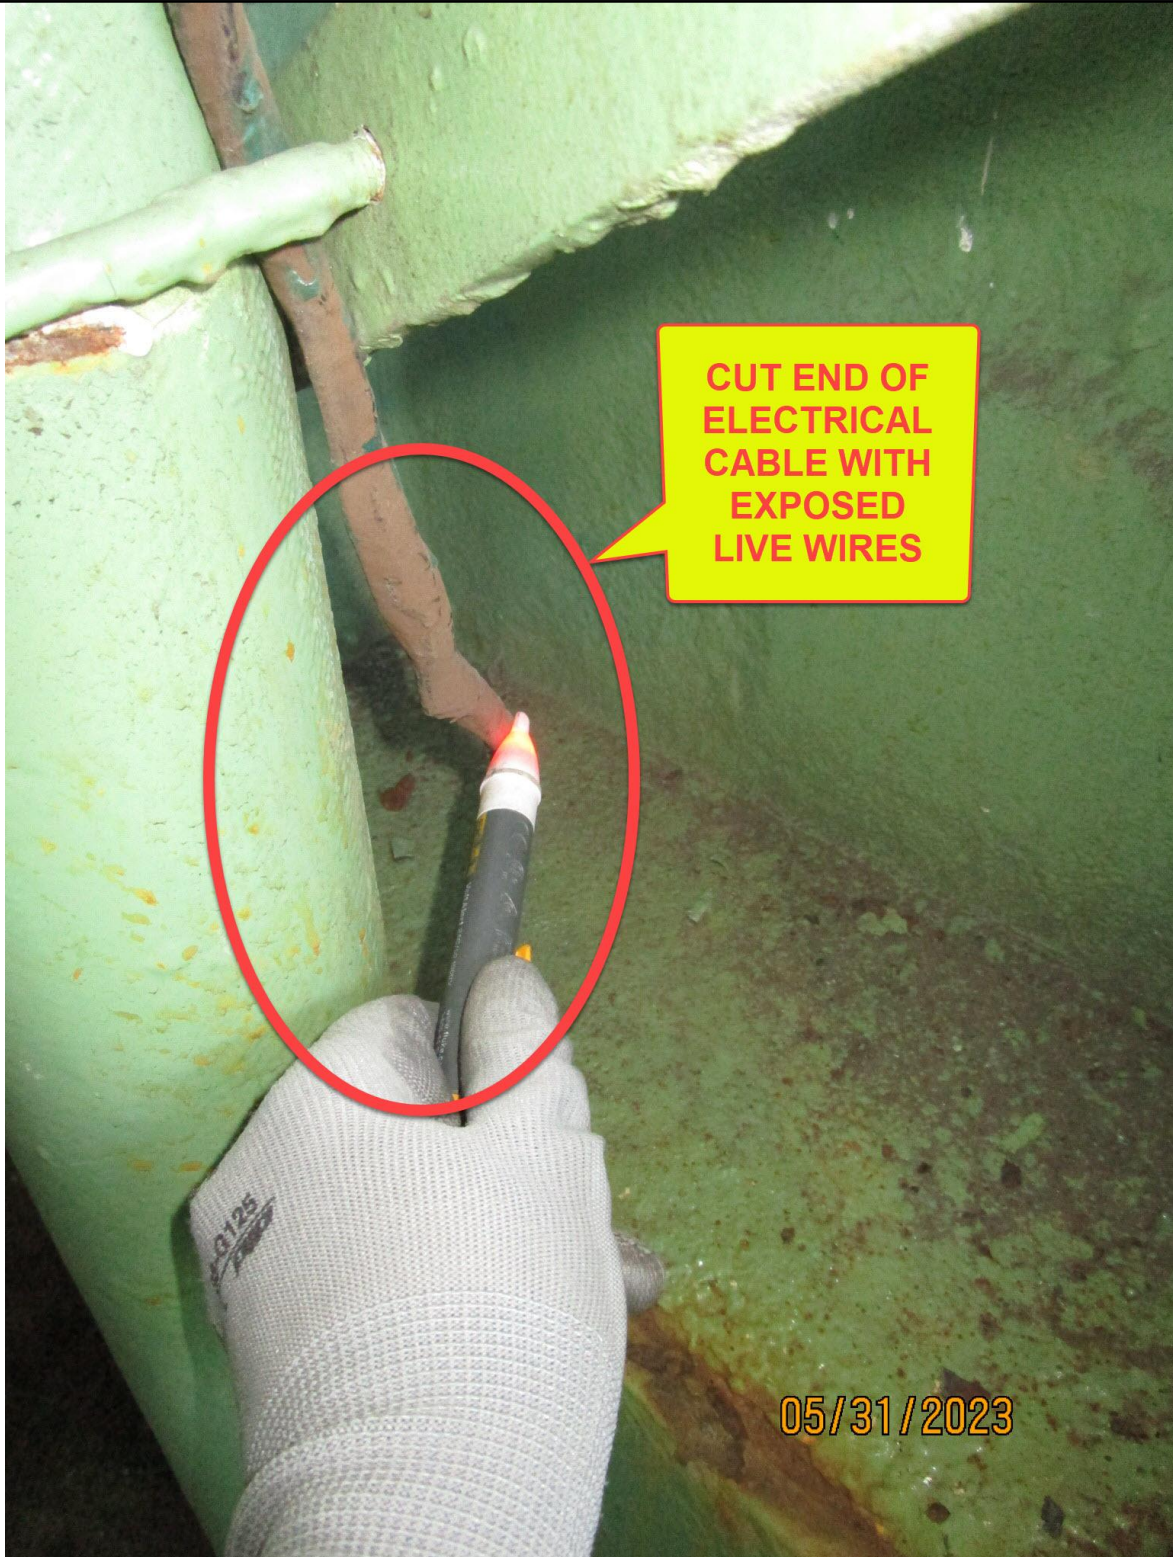
Photo Number: 5

**Attachment Description:** Close-up view of cut electrical cable with exposed live wires. Looking Begin Right.
